Manhole Inspection Summary

Manhole # S25A__005MH

Location Address: **1212 HARLEM AVE**

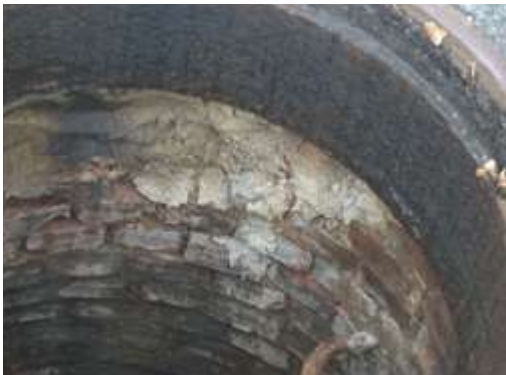
Defect 2

Condition: ☐ Sound ☐ Cracked ☐ Root Intrusion ☐ Loose Brick ☒ **Deteriorated**

DETERIORATED CORBEL

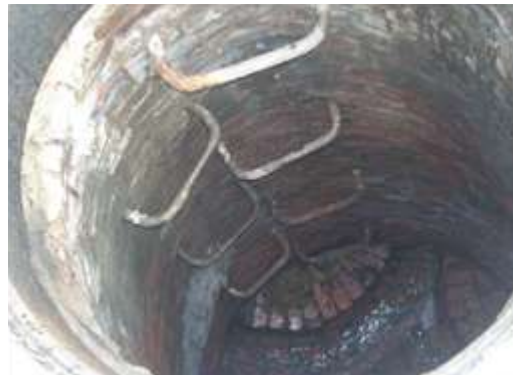
Defect 1

Count: **7** Missing: **0** ☒ **Corroded**

CORRODED STEPS

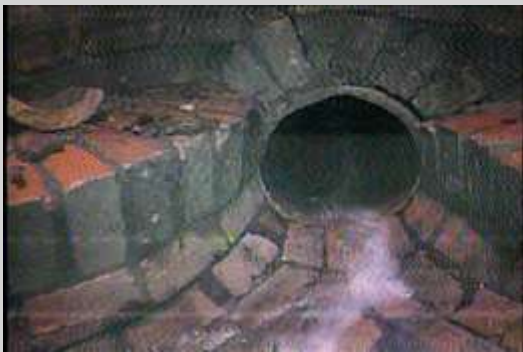
12 O'Clock Outflow

8 in. Circular Gravity Sewer
Pipe Out @ 12 O'Clock

Pipe Height: **8.4** (in.) Rod and Bar (Angled)
Pipe Material: **Clay** ☐ Pipe Lined
Invert Depth: **11.26** (ft.) Flow Characteristics: **Slow**
Deposits: ☒ None ☐ Mud ☐ Sludge ☐ Debris ☐ Grease
Silt Depth: (in.) Deposits Extent:
Infiltration: **None** Pipe Seal Cond: **Sound**

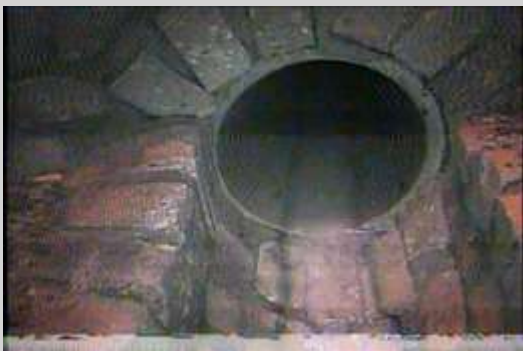
3 O'Clock Inflow

8 in. Circular Gravity Sewer
Pipe In @ 3 O'Clock

Pipe Height: **8.4** (in.) Rod and Bar (Angled)
Pipe Material: **Clay** ☐ Pipe Lined
Invert Depth: **10.70** (ft.) Flow Characteristics: **Slow**
Deposits: ☒ None ☐ Mud ☐ Sludge ☐ Debris ☐ Grease
Silt Depth: (in.) Deposits Extent:
Infiltration: **None** Pipe Seal Cond: **Sound**

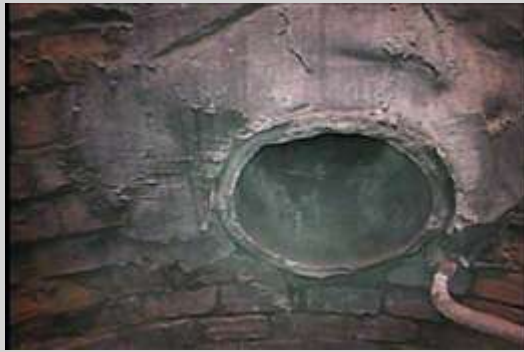
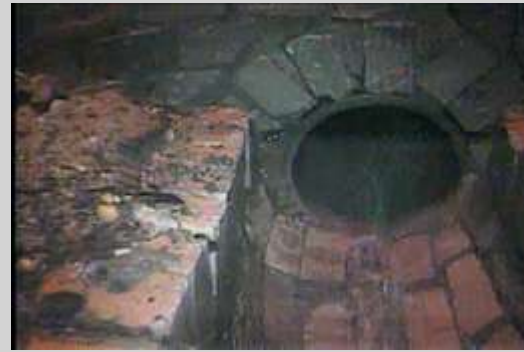
9 O'Clock Inflow

Pipe In @ 9 O'Clock

Drop In @ 9 O'Clock

Infiltration: **None** Pipe Seal Cond: **Cracked**

Drop: **Outside** Rod and Bar

Drop Condition: **Open**
